POWERCEM
TEMPORARY ROADWAY TRIALS
NEAR CHISLET, KENT
INTERIM REPORT

Report 1306/1

M J Reeve, CSci, FSoilSci, CWEM, MBIAC

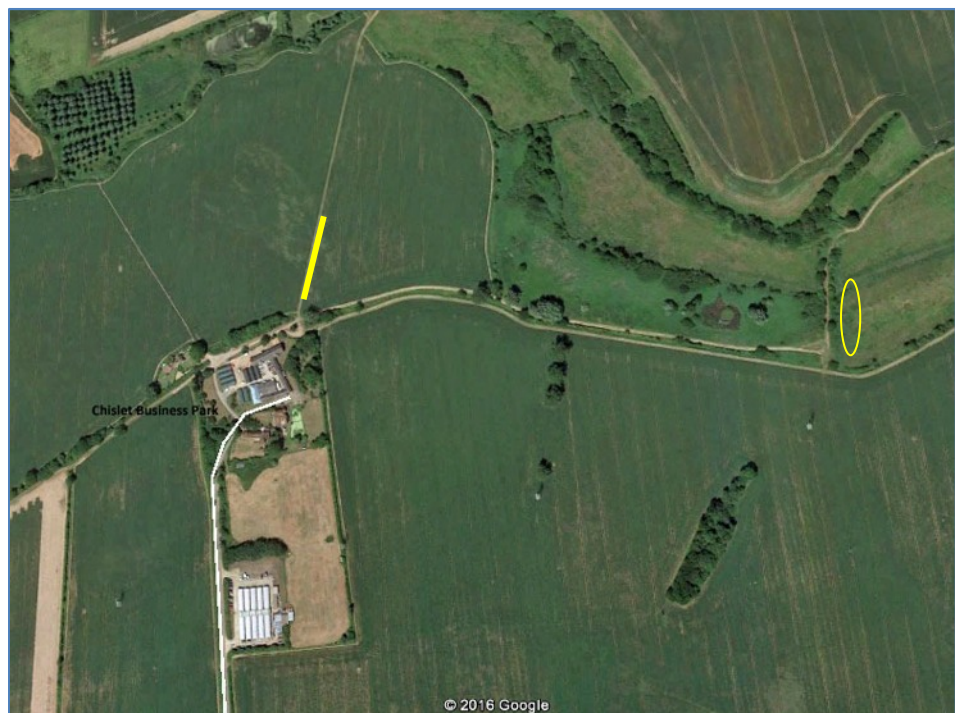
- 1.2 The 100 m-long, 2.5 m-wide trial roadway (marked in yellow on the Google Earth image below) was installed in February 2017 along the edge of an arable field to the north-west of Chislet Business Park. The field was to be sown with a crop of beans for the 2017 growing season.
- 1.3 The land slopes gently down from a low ridge at the northern end of the trial strip. The soils are derived from a thin cover of drift deposits over London Clay. Investigation by soil auger alongside the trial strip showed 250-300 mm of heavy clay loam topsoil, either directly on slowly permeable clay subsoil or on a thin layer of heavy clay loam subsoil between the topsoil and clay. The topsoil is stonier along the upper half of the trial strip than along the lower half, coinciding with the mottled tone on the Google Earth image below.

- 1.4 A second trial roadway planned for a field to the east (circled) had not been created due to ground conditions being too wet.

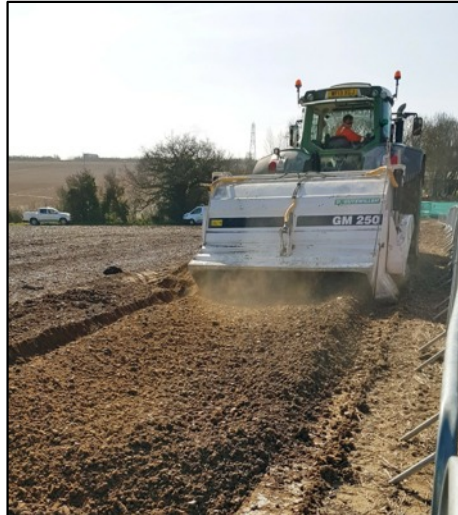
- 2.1 The trial roadway was removed on 15th March 2017 using a Fendt 939 4-wheel drive tractor with a Gutzwiller GM250 mixing/rotovation drum to break up cementation. The process is pictured below.

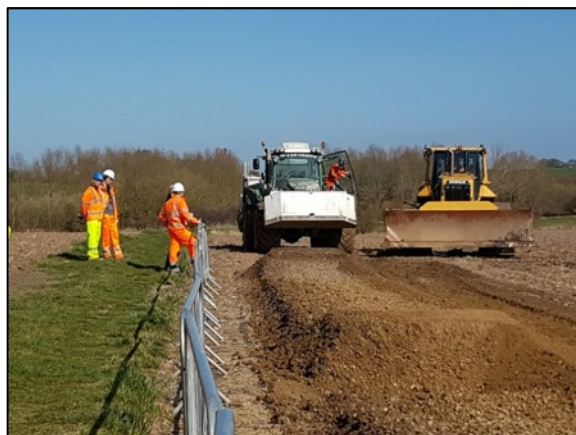
- 2.2 The removal operation was witnessed by the author of this report, representatives of PowerCem, Barton Plant and Carillion, as well as a soil science consultant working for National Grid, a geotechnical consultant working for PowerCem and Laura Headley from the farm hosting the trial.
- 2.3 The mixing produced a soil surface slightly raised above the adjacent field, particularly so along the first 20 m of roadway removal (see image below) where the tool depth had been set too deep (500 mm) and subsoil clay had become mixed with the agricultural topsoil. However, grading and lightly consolidating the strip using a tracked Caterpillar D6 bulldozer resulted in a soil surface at the same level as the adjacent land.
